# *Saint Cloud Area Planning Organization's 2015-2019 Pavement Condition Report*

Prepared by the Saint Cloud  
Area Planning Organization  
October 2020

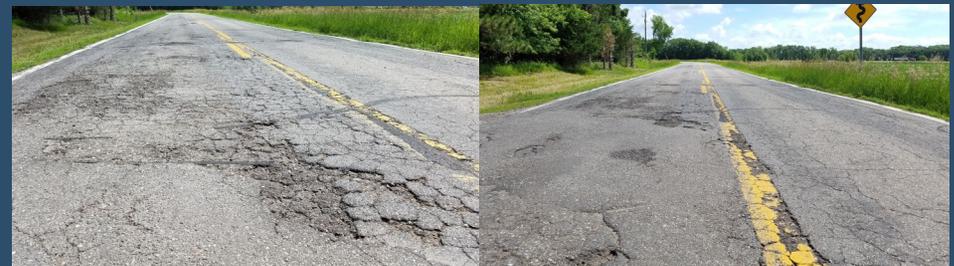
*\*Example of poor pavement quality on Graintevew Road in Waite Park.*

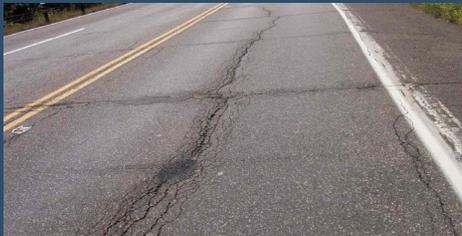
**Cracking** – A visible line in the surface of the pavement due to a variety of environmental conditions and vehicle usage.

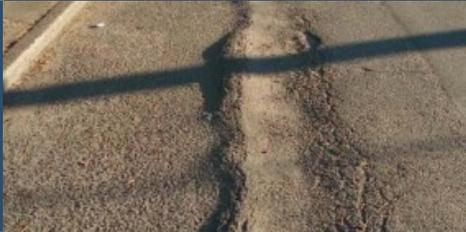
**Rutting** – A surface depression located in the wheel path of the travel lane.

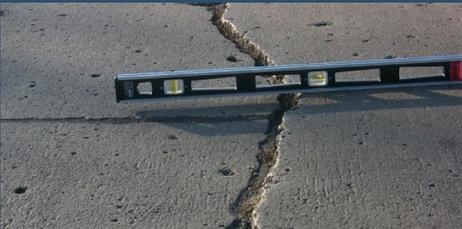
**Faulting** – A difference in elevation between adjacent pavement due to environmental conditions and vehicle usage.

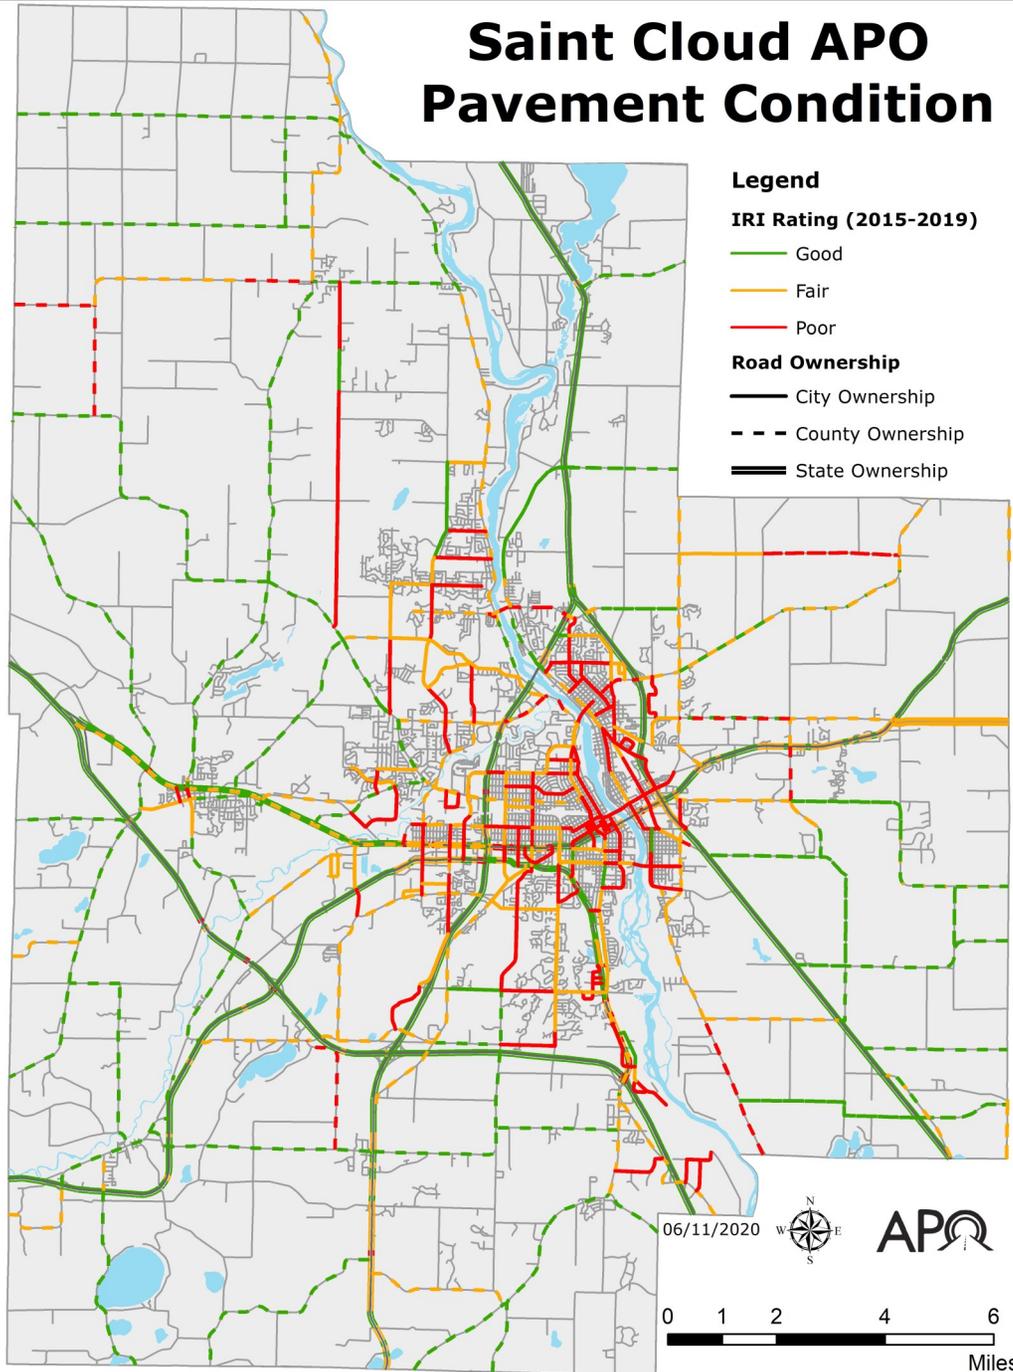
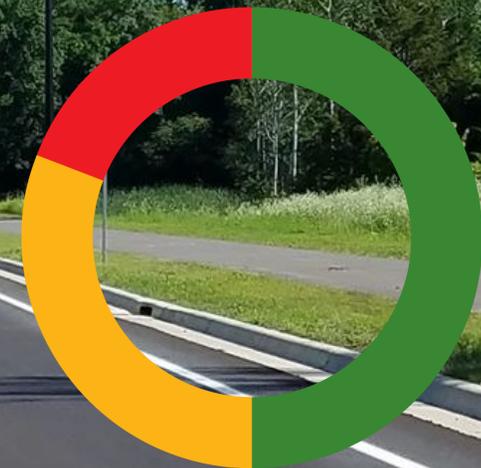
## Saint Cloud APO Pavement Condition

| Condition | Percentage | Lane Miles |
|---|---|---|
| Good | 50.0% | 518.9 Lane Miles |
| Fair | 31.1% | 322.6 Lane Miles |
| Poor | 18.9% | 196.5 Lane Miles |

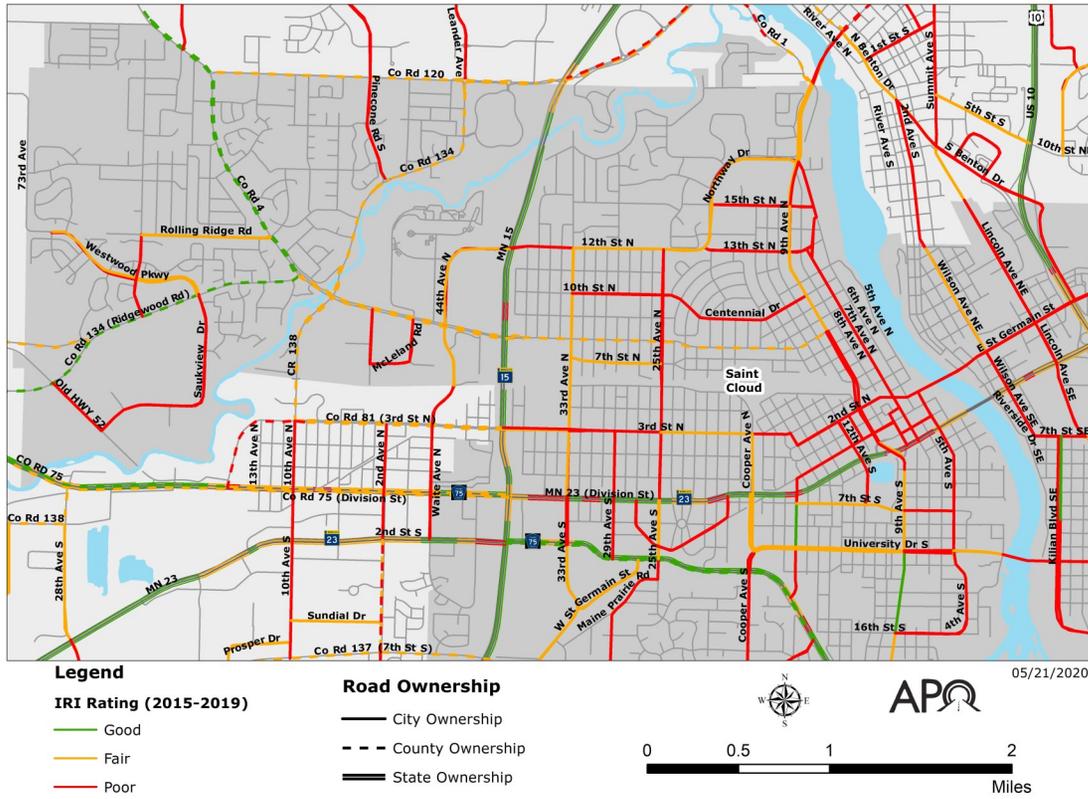
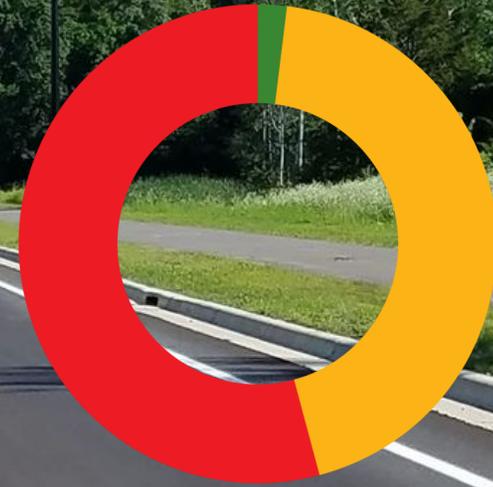
North Saint Cloud Pavement Condition

Good  
**2.2%**  
3.4 Lane Miles

Fair  
**43.8%**  
68.3 Lane Miles

Poor  
**54.0%**  
84.3 Lane Miles

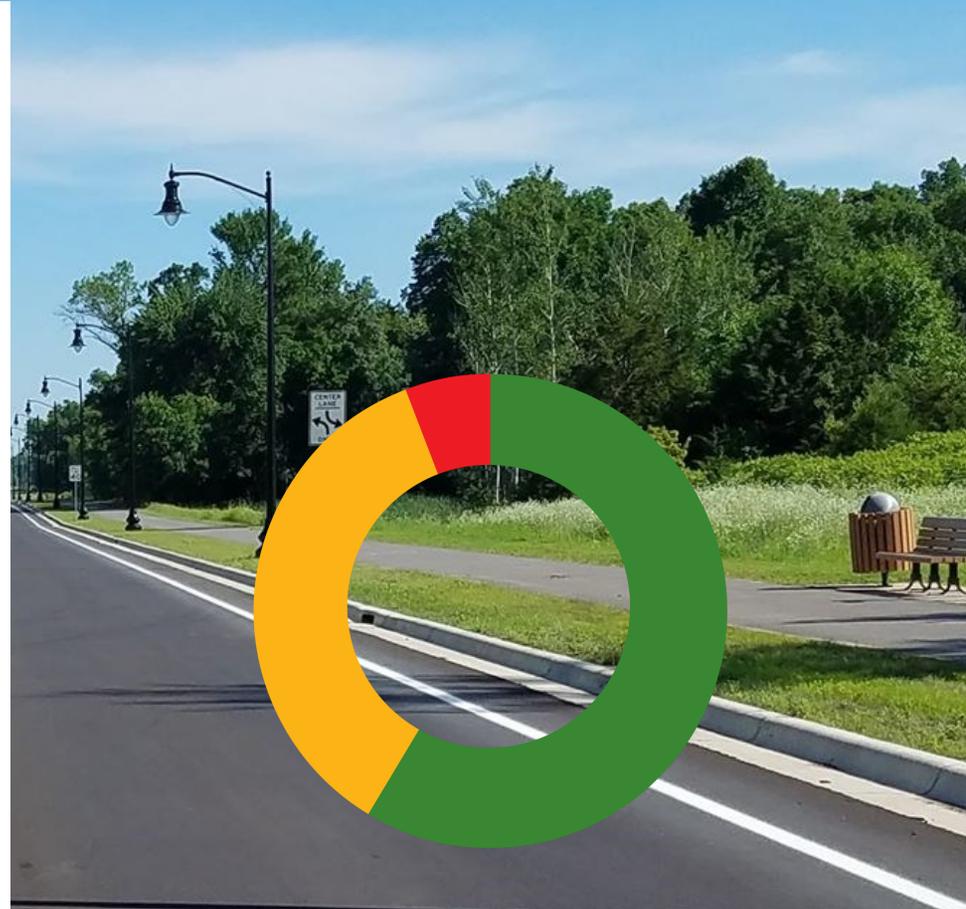
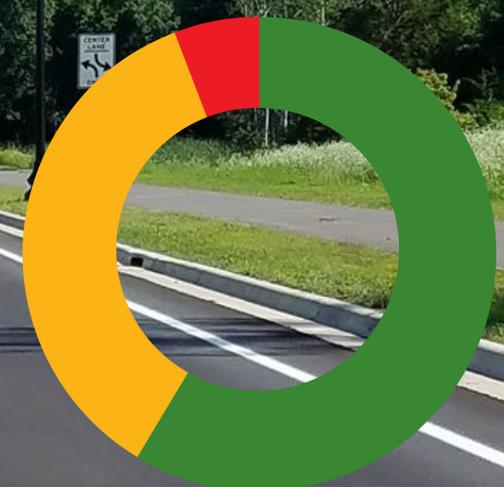
# Stearns County's Pavement Condition

| Condition | Percentage | Lane Miles |
|---|---|---|
| Good | 58.7% | 183.3 Lane Miles |
| Fair | 35.5% | 110.9 Lane Miles |
| Poor | 5.8% | 18.1 Lane Miles |

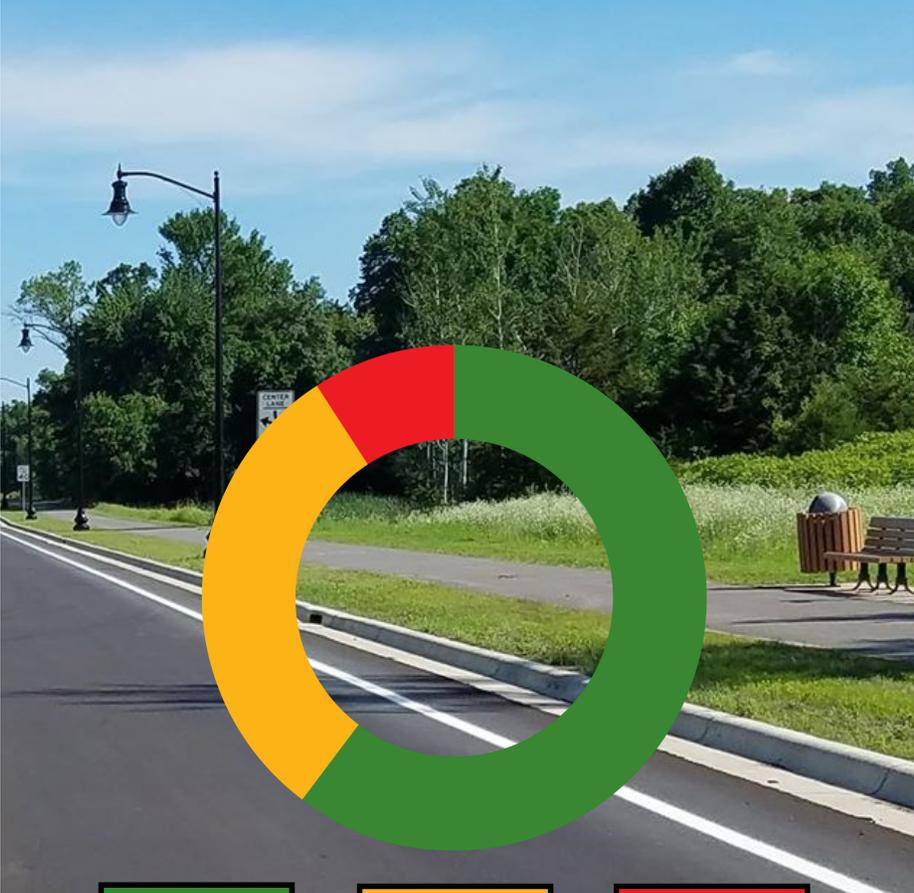
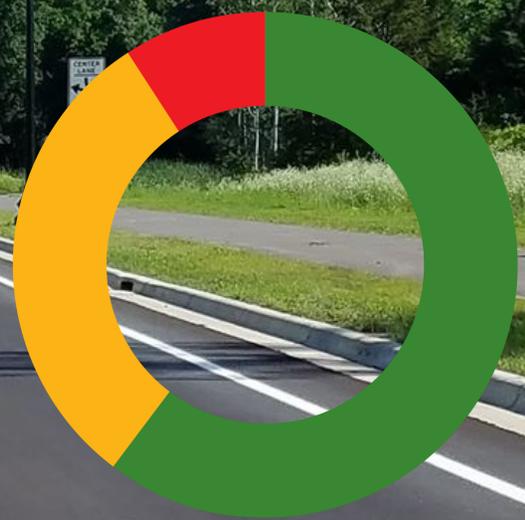
# Sherburne County's Pavement Condition

| Condition | Percentage | Lane Miles |
|---|---|---|
| Good | 60.5% | 42.4 Lane Miles |
| Fair | 30.6% | 21.4 Lane Miles |
| Poor | 8.9% | 6.2 Lane Miles |

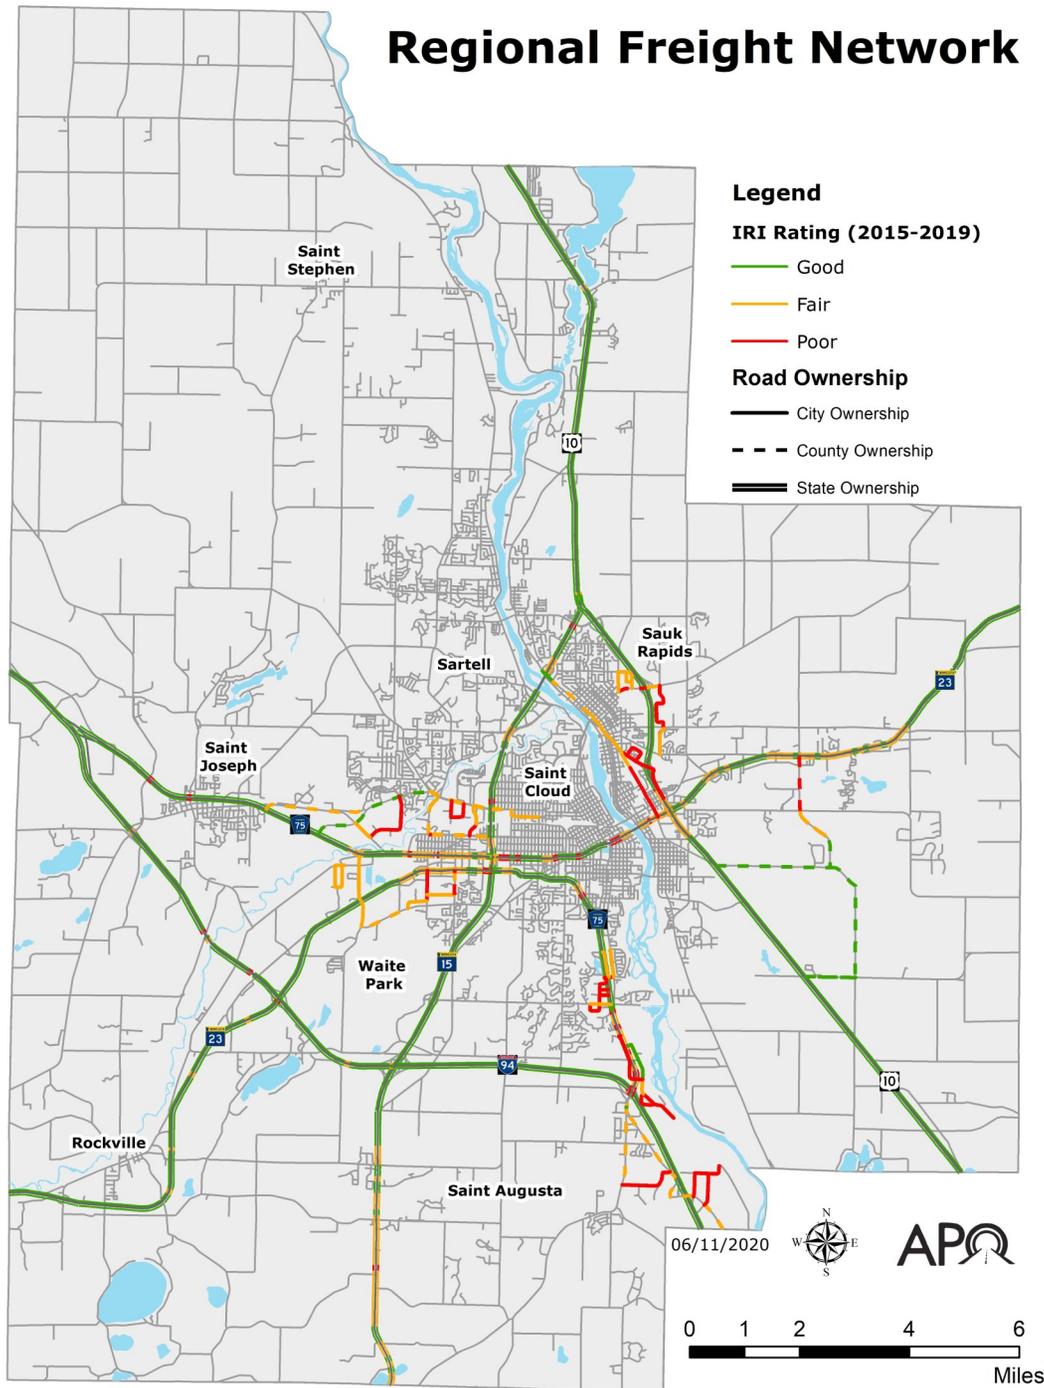
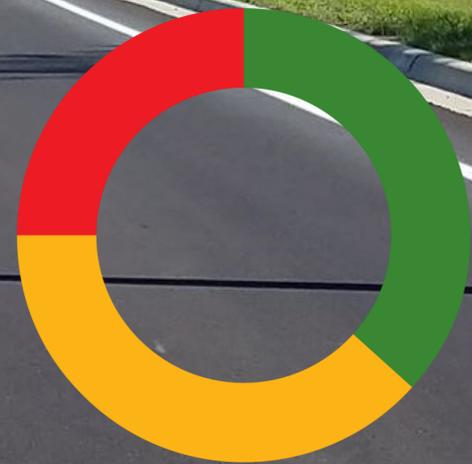
## Regional Freight Network

Good  
**36.8%**  
55.1 Lane Miles

Fair  
**38.3%**  
57.4 Lane Miles

Poor  
**24.9%**  
37.3 Lane Miles

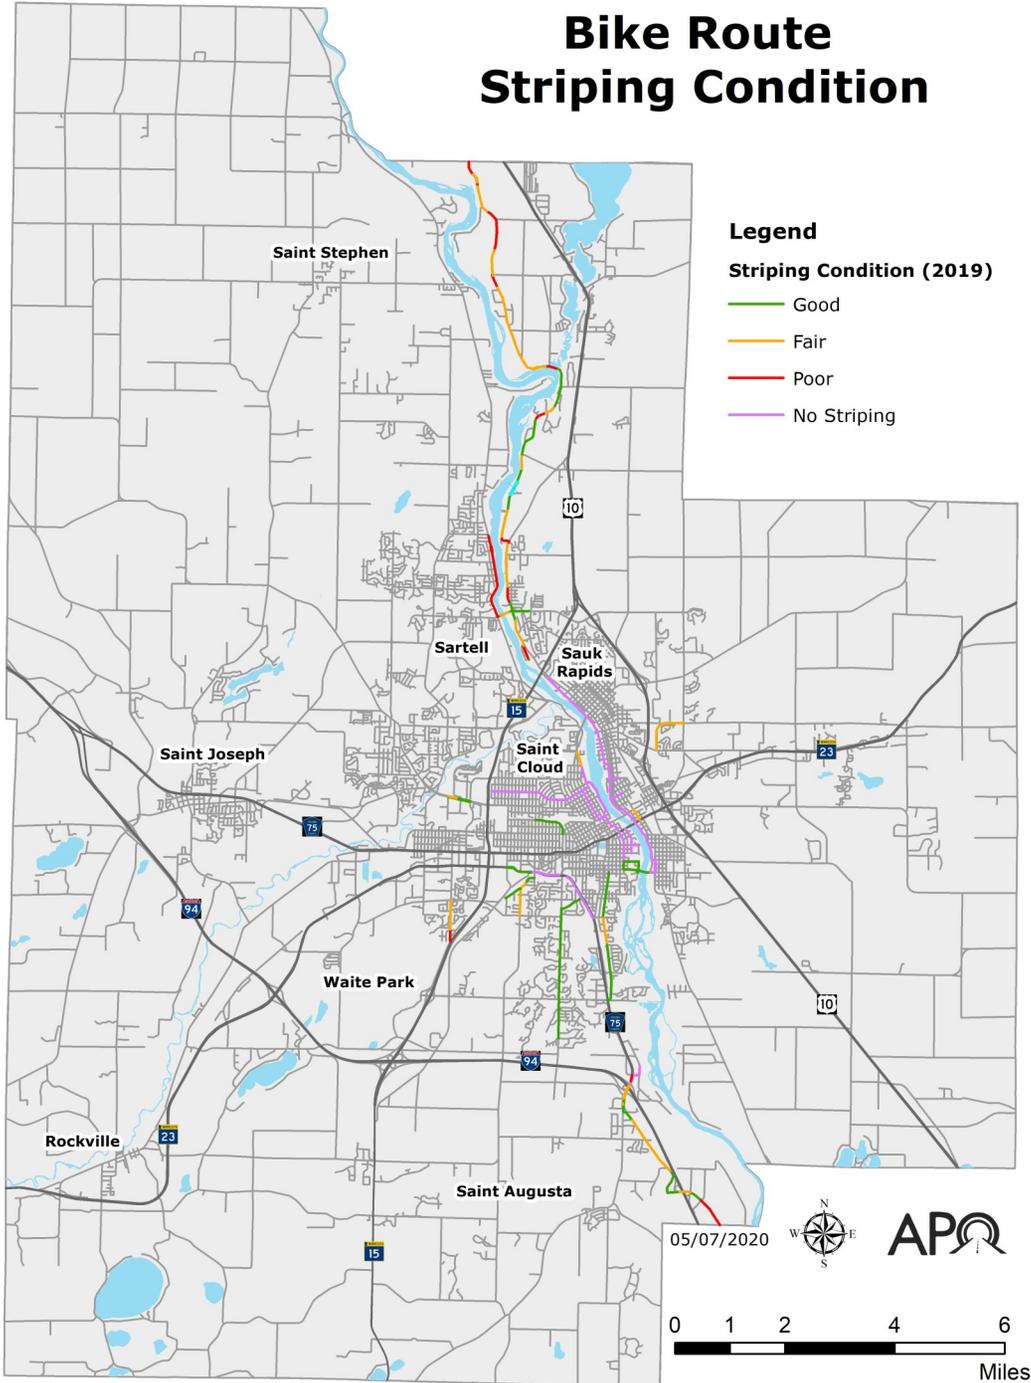
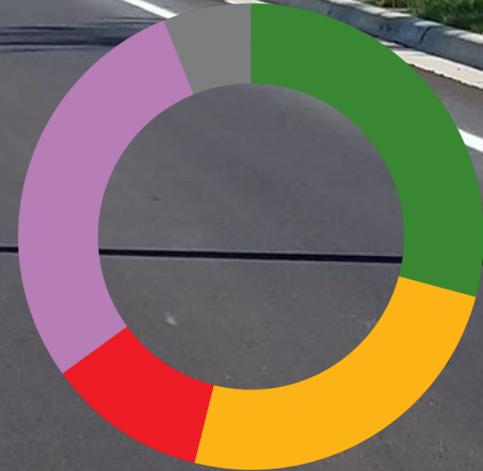
## Bike Route Striping Condition

In 2019, GoodPointe Technology visually surveyed the condition of all signed bike route pavement markings in the APO planning area. These bike routes include bike lanes, paved shoulders and shared lanes. Some bike routes have no striping thus the category none or no striping was added. These routes are typically shared lanes where the person who cycles and the motorist are sharing the same lane simultaneously. The not surveyed category include facilities installed in 2019 or were not part of the study.

| Good | Fair | Poor | None | Not Surveyed |
|---|---|---|---|---|
| 29.2% | 24.8% | 11.1% | 28.7% | 6.1% |
| 23.8 Lane Miles | 20.2 Lane Miles | 9.0 Lane Miles | 23.4 Lane Miles | 5.0 Lane Miles |

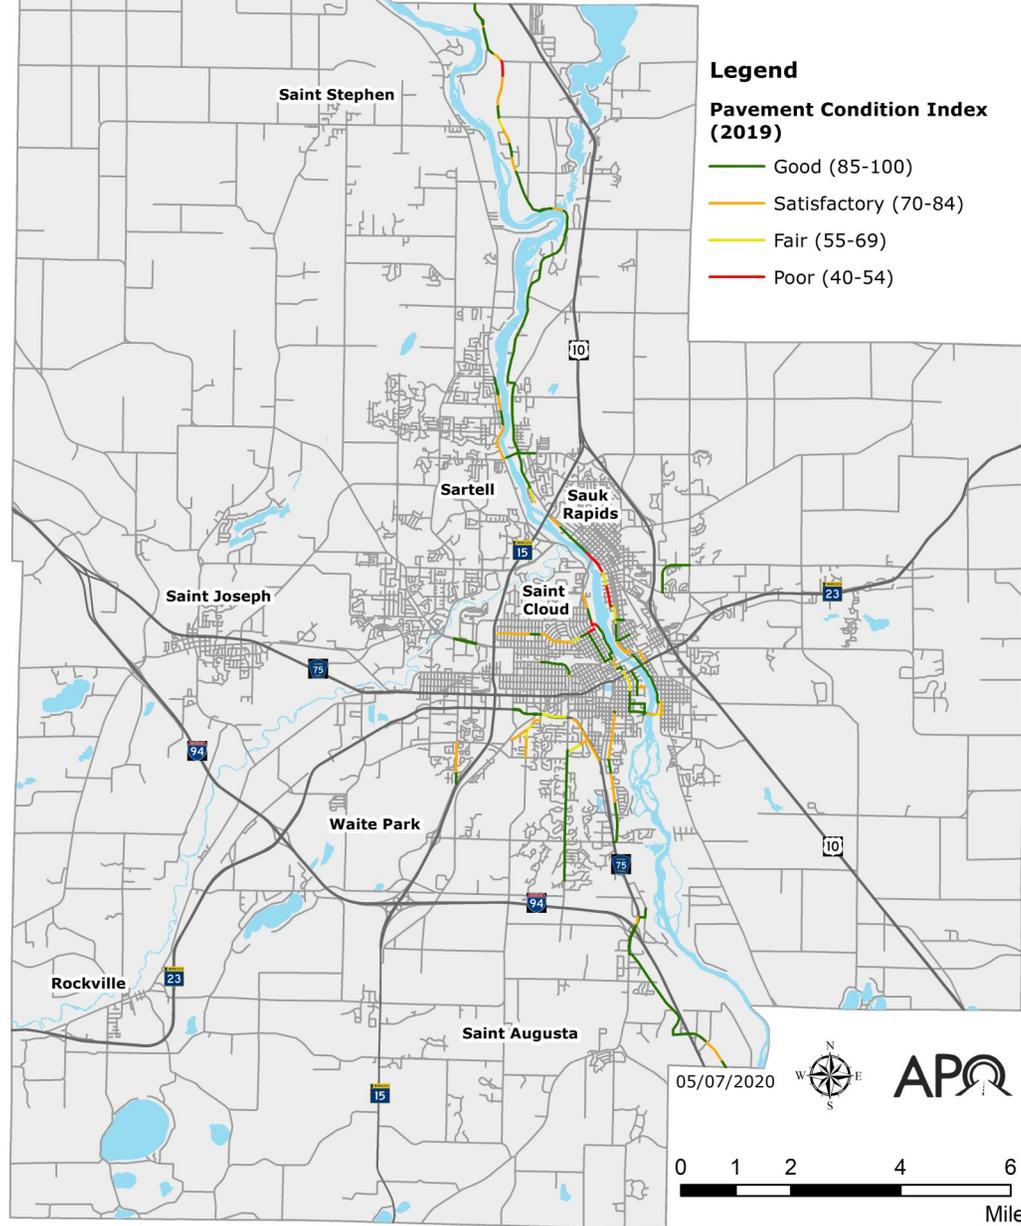
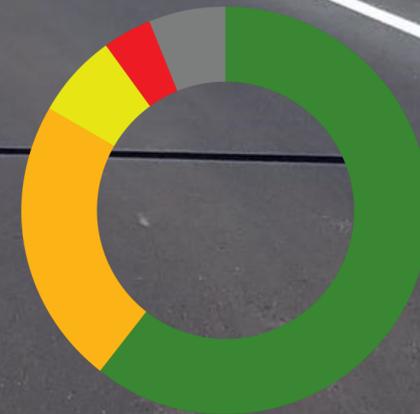
## Bike Route Pavement Condition Index (PCI)

In 2019, GoodPointe Technology collected the pavement condition index (PCI) of all signed bike routes. During a PCI survey, visible signs of deterioration within a segment are recorded and given a score. In general terms, maintenance activities such as crack sealing and patching often provide benefit when the PCI is above 60. However, as the pavement continues to deteriorate, more complex and expensive treatments will be necessary. Pavements with a PCI between 40 and 60 are good candidates for a variety of major repairs ranging from overlays to reconstruction. Once the PCI drops below 40, reconstruction is typically the only viable alternative.

| Good | Satisfactory | Fair | Poor | Not Surveyed |
|---|---|---|---|---|
| 60.7% | 22.9% | 6.6% | 3.7% | 6.1% |
| 49.4 Lane Miles | 18.6 Lane Miles | 5.4 Lane Miles | 3.0 Lane Miles | 5.0 Lane Miles |
